Uniform Mitigation Verification Inspection FormMaintain a copy of this form and any documentation provided with the insurance policy

Inspection Date: 05/21/2024		
Owner Information		
Owner Name: Cedar Point Condominiums Village 7 Association		Contact Person: John Dzwlewicz
Address: 2929 SE Ocean Blvd Building: 125 (Units 1-10)		Home Phone:
City: Stuart	Zip: 34996	Work Phone:
County: Martin		Cell Phone: 631-896-2814
Insurance Company:		Policy #:
Year of Home: 1971	# of Stories: 2	Email: jdzlewicz@gmail.com

Inspectors Initials GS Property Address 2929 SE Ocean Blvd Building: 125 (Units 1-10), Stuart, FL 34996

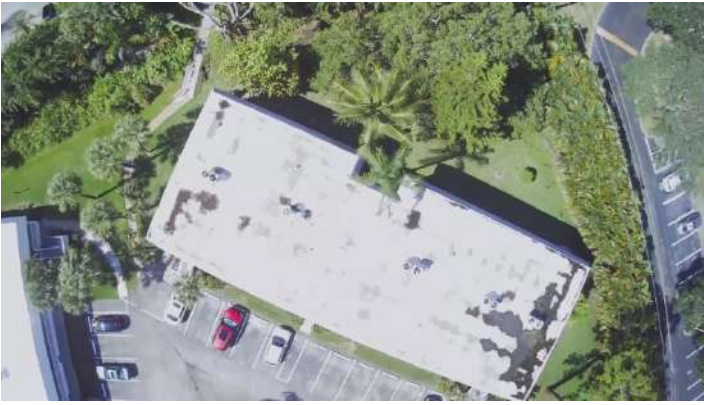
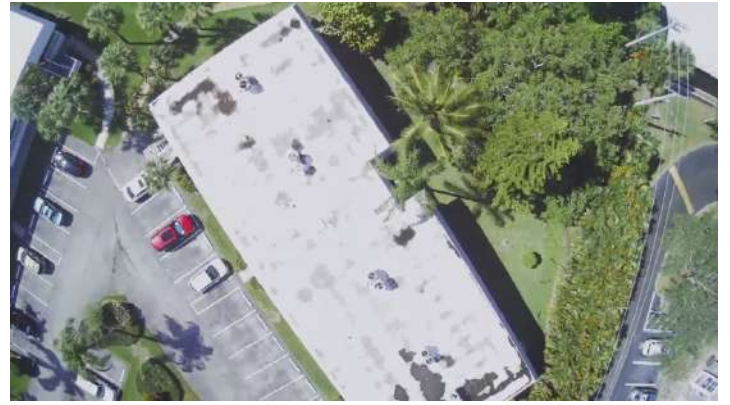
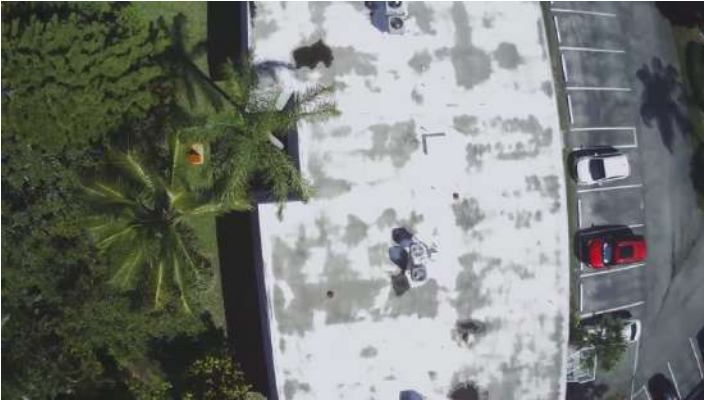
ROOF

2.1 Roof Covering Type:	Permit Application Date	FBC or MDC Product Approval #	Year of Original Installation or Replacement	No Information Provided for Compliance
<input type="checkbox"/> 1. Asphalt/Fiberglass Shingle	____/____/____	_____	_____	<input type="checkbox"/>
<input type="checkbox"/> 2. Concrete/Clay Tile	____/____/____	_____	_____	<input type="checkbox"/>
<input type="checkbox"/> 3. Metal	____/____/____	_____	_____	<input type="checkbox"/>
<input type="checkbox"/> 4. Built Up	____/____/____	_____	_____	<input type="checkbox"/>
<input type="checkbox"/> 5. Membrane	____/____/____	_____	_____	<input type="checkbox"/>
<input checked="" type="checkbox"/> 6. Other Polyurethane Elastomeric Coating	09/14/2020	BLD2020090677	2020	<input type="checkbox"/>

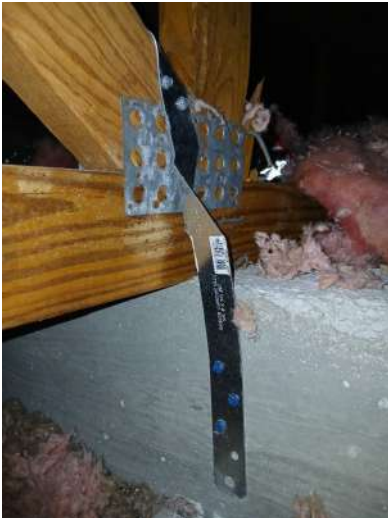
SINGLE WRAP - FRONT

Metal connectors consisting of a single strap that wraps over the top of the truss/rafter and is secured with a minimum of 2 nails on the front side and a minimum of 1 nail on the opposing side.
