Uniform Mitigation Verification Inspection FormMaintain a copy of this form and any documentation provided with the insurance policy

Inspection Date: 05/21/2024		
Owner Information		
Owner Name: Cedar Point Condominimums Village 7 Association		Contact Person: John Dzwlewicz
Address: 2929 SE Ocean Blvd Building: 122 (Units 1-10)		Home Phone:
City: Stuart	Zip: 34996	Work Phone:
County: Martin		Cell Phone: 631-896-2814
Insurance Company:		Policy #:
Year of Home: 1971	# of Stories: 2	Email: jdzlewicz@gmail.com

Inspectors Initials GS Property Address 2929 SE Ocean Blvd Building: 122 (Units 1-10), Stuart, FL 34996

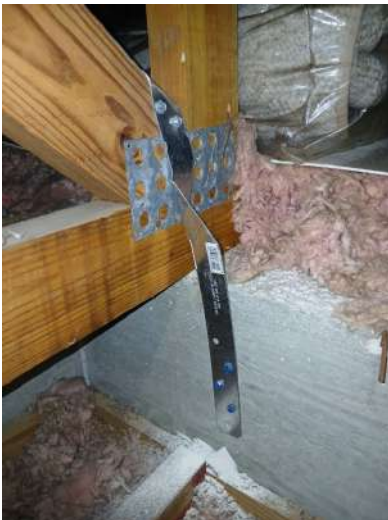
SINGLE WRAP - FRONT

Metal connectors consisting of a single strap that wraps over the top of the truss/rafter and is secured with a minimum of 2 nails on the front side and a minimum of 1 nail on the opposing side.
