Uniform Mitigation Verification Inspection FormMaintain a copy of this form and any documentation provided with the insurance policy

Inspection Date: 05/21/2024		
Owner Information		
Owner Name: Cedar Point Condominiums Village 7 Association		Contact Person: John Dzwlewicz
Address: 2929 SE Ocean Blvd Building: 121 (Units 1-10)		Home Phone:
City: Stuart	Zip: 34996	Work Phone:
County: Martin		Cell Phone: 631-896-2814
Insurance Company:		Policy #:
Year of Home: 1971	# of Stories: 2	Email: jdzlewicz@gmail.com

Inspectors Initials GS Property Address 2929 SE Ocean Blvd Building: 121 (Units 1-10), Stuart, FL 34996

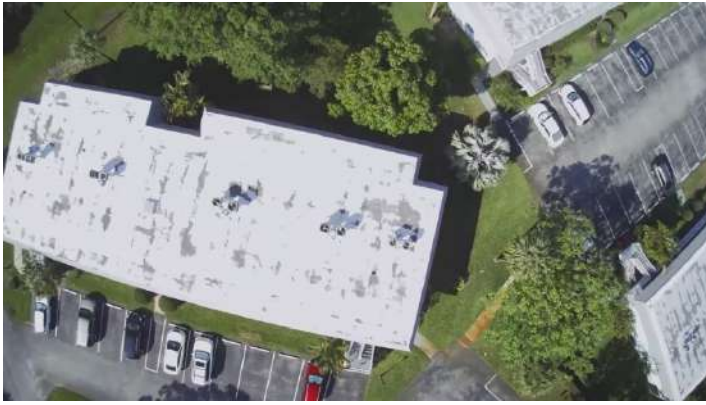
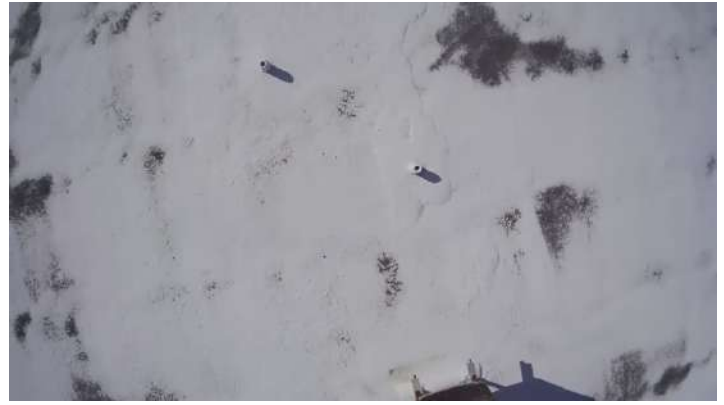
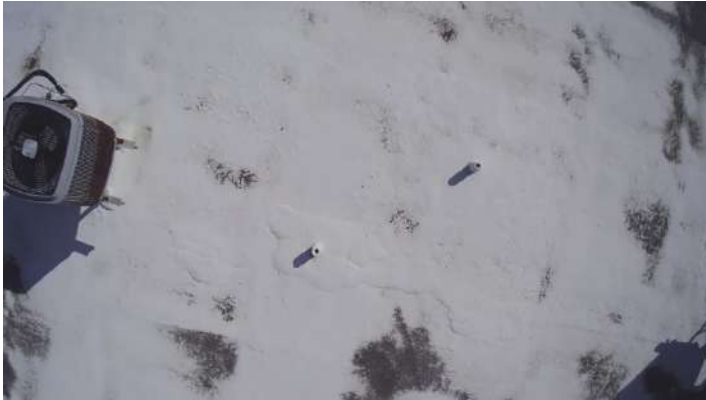
ROOF

2.1 Roof Covering Type:	Permit Application Date	FBC or MDC Product Approval #	Year of Original Installation or Replacement	No Information Provided for Compliance
<input type="checkbox"/> 1. Asphalt/Fiberglass Shingle	____/____/____	_____	_____	<input type="checkbox"/>
<input type="checkbox"/> 2. Concrete/Clay Tile	____/____/____	_____	_____	<input type="checkbox"/>
<input type="checkbox"/> 3. Metal	____/____/____	_____	_____	<input type="checkbox"/>
<input type="checkbox"/> 4. Built Up	____/____/____	_____	_____	<input type="checkbox"/>
<input type="checkbox"/> 5. Membrane	____/____/____	_____	_____	<input type="checkbox"/>
<input checked="" type="checkbox"/> 6. Other Polyurethane Elastomeric Coating	04/26/2021	BLD2021040980	2021	<input type="checkbox"/>

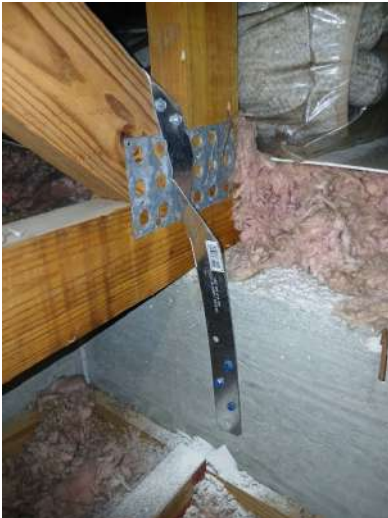
Metal connectors consisting of a single strap that wraps over the top of the truss/rafter and is secured with a minimum of 2 nails on the front side and a minimum of 1 nail on the opposing side.

SINGLE WRAP - FRONT

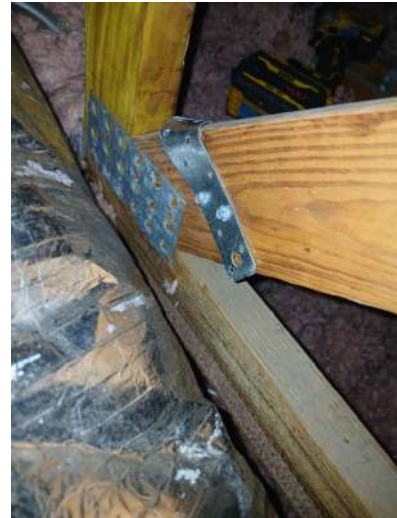
SINGLE WRAP - REAR
